A close look at the Nason parking brake switch And our solution for a replacementⁱ

By Bob Nodine

June 2014

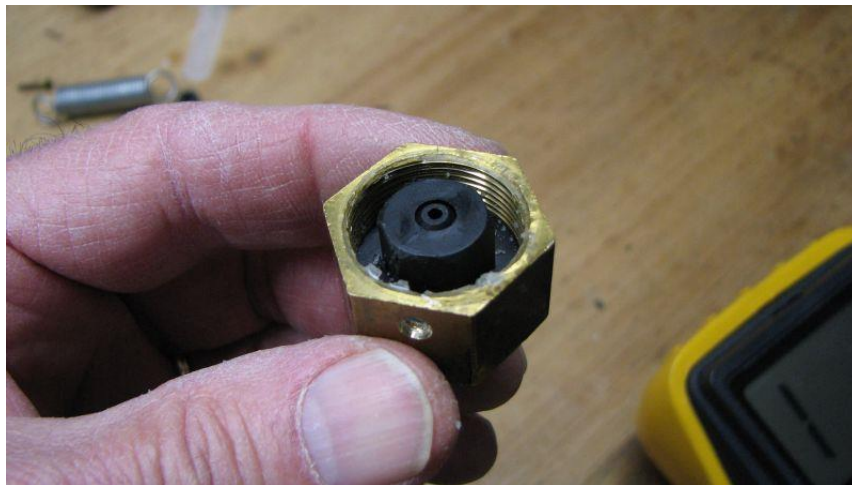
Figure 2 Push actuator and brass housing

In Figure 2 the push actuator can be seen in the center of the black nut. The actuator is fully retracted in the photo and extends approximately 0.085 of an inch when 66 PSI or greater of air pressure is applied. The actuator pushes against the lever of a microswitch. After disassembly it became evident that Nason relies on the mechanical properties of the microswitch as part of the calibration. We connected the actuator housing back to the air compressor and turned the regulator down to about 5 PSI. Slowly bringing the pressure up the actuator started to extend at about 40 PSI and was fully extended at 70 PSI. The 66 PSI calibration claim is based on the size of the diaphragm and the tension of the spring. See

Figure 4. The actuator is fully extended at the calibration pressure and against a stop. Air pressure above 66 PSI does not increase the actuator travel against the microswitch lever. In Figure 2 note the threads inside the brass housing of the pressure actuator and the hole near my thumb where a set screw was removed. Note in Figure 5 that the housing containing the microswitch has mating threads that allow the housing to screw into the pressure actuator. It is assumed that Nason calibrates the pressure at which contacts A and B close by applying 66 PSI and screwing the housing into the pressure actuator until the contacts make. The set screw is then tightened and a sealant applied around the threads. When taking apart the second Nason switch we determined that the switch housing could be screwed further into the brass housing after removing the set screw. That supports our assumption that the calibration partially relies on the mechanical properties of the microswitch.

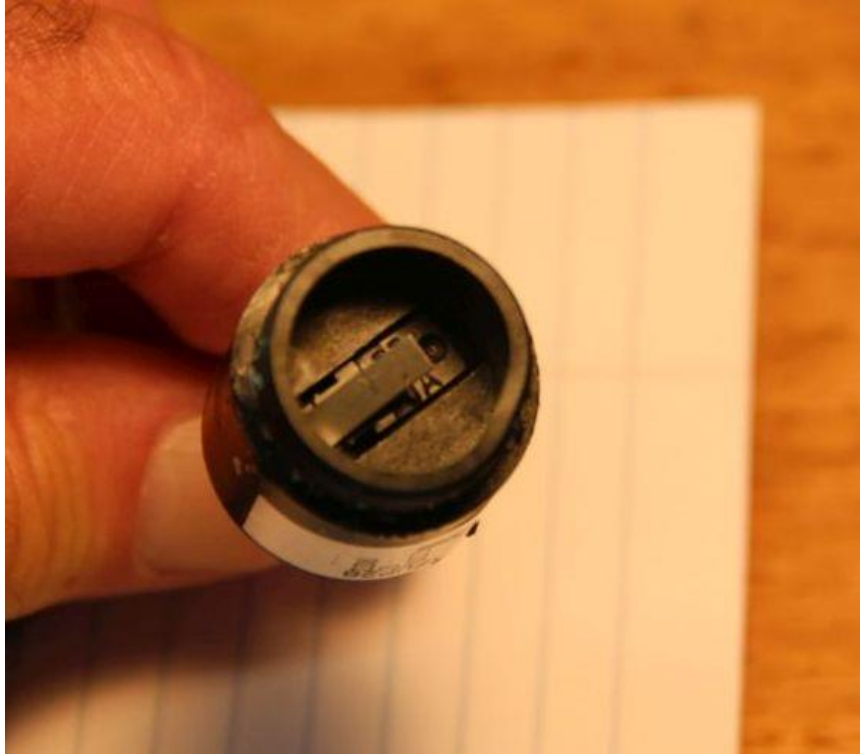
Figure 3 Actuator lever for micro switch

Over time the microswitch weakens mechanically until the travel distance of the push actuator is no longer adequate to close contacts A and B but sufficient to open contacts A and C. In Figure 3 note the microswitch actuator lever inside the switch housing. We pushed on the lever as far as the housing would allow and were able to make contacts A and B conduct. The connection was resistive at 51 ohms as shown in Figure 6. After disassembling the second failed Nason switch we repeated this test with improved continuity at about 5 ohms. Neither of the microswitches exhibited the snap action normally associated with a microswitch. We assume that the snap action was present when the switches were first placed in service but now absent after internal mechanical failure. If one were inclined, it might be possible to extend the service of a failing Nason switch by screwing the switch housing further into the pressure actuator. It is our opinion that the switch would inevitably cause problems later.

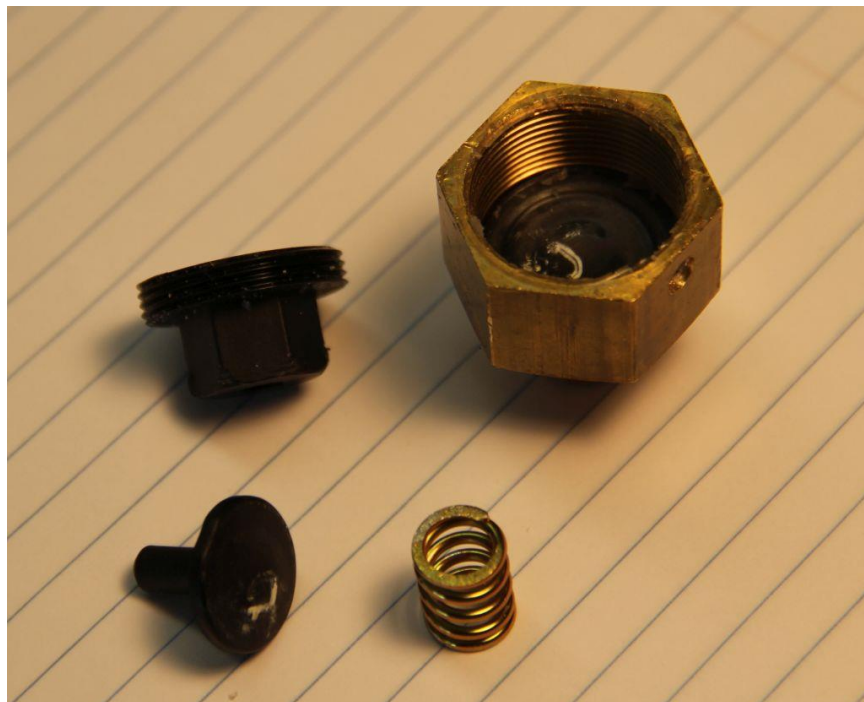
Figure 4 Pressure actuator disassembled

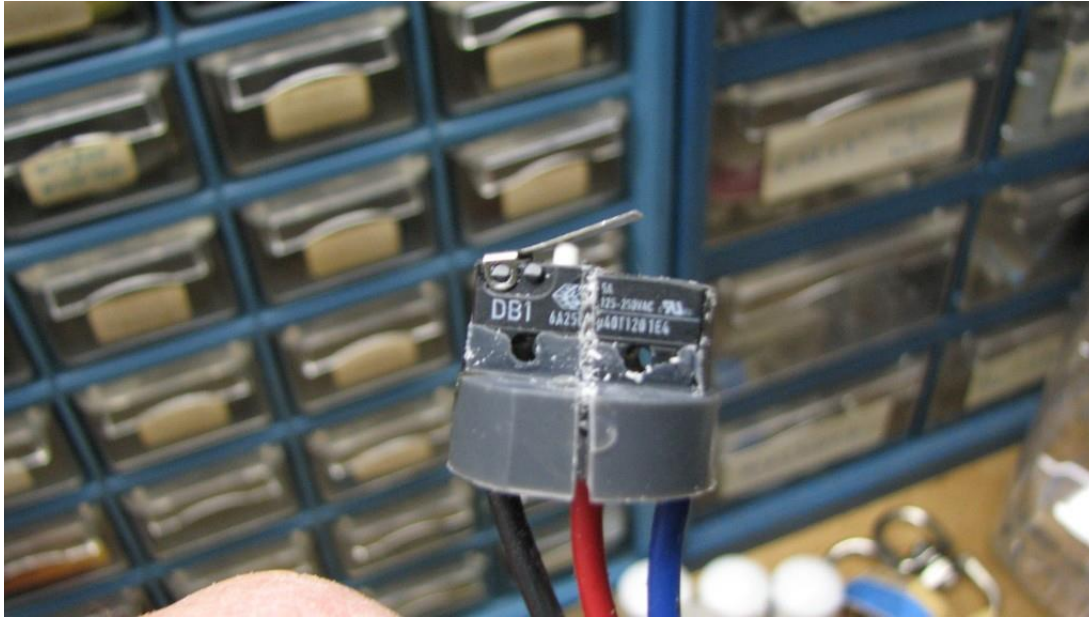
Figure 7 Housing removed reveals Cherry micro switch

After performing the electrical tests we split the switch housing of the Nason pressure switch to further disassemble it. That revealed the potted Cherry microswitch. See Figure 7. Once the housing around the microswitch was removed we were able to achieve maximum travel of the actuator. This reduced the resistance measurement between contacts A and B to 5 ohms on the original switch. Again the snap action feel expected when a microswitch is pushed was absent.

The Cherry microswitch is a DB1 series. The Cherry specificationⁱⁱⁱ for that switch claims an operating life of 10,000 cycles. That is 100 times less than what Nason claims. Cherry does state the mechanical life is 15 million cycles but our inspection indicates mechanical degradation of the Cherry microswitch is the cause of failure of both Nason pressure switches removed from our coach. Possibly Nason received a large order of the Cherry switches that were defective and manufactured the pressure switches without that knowledge. Maybe the potting process used by Nason affects the internal parts of the Cherry switch and shortens the life expectancy. The bottom line is that after having two parking brake switches fail in six years, we are not confident that Nason has improved the life of this product. Our real world experience with that switch resulted in an estimated life span of 2000 cycles motivating us to fabricate a substitute parking brake switch. We are confident that the weak point is the microswitch and wish Monaco had chosen a SPST pressure switch for the parking brake.

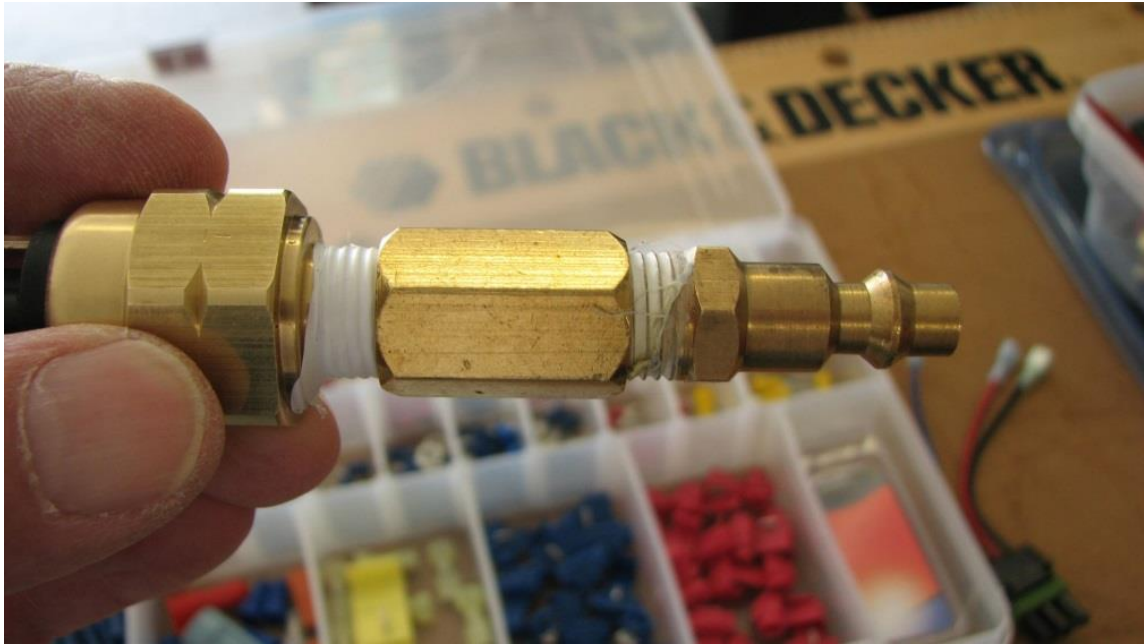
Figure 11 Temporary air chuck fitted to Cole-Parmer pressure switch

Before use the Cole-Parmer pressure switch is calibrated to close the contacts at 65 PSI of air pressure. A temporary male air fitting is attached to the pressure switch as shown in Figure 11. The regulator on the air source is adjusted to 65 PSI as in Figure 12. The multimeter set on a low ohm range is connected between the terminals on the Cole-Parmer pressure switch and the air hose connected. The Cole-Parmer pressure switch comes out of the box set to a higher pressure than 65 PSI, thus the multimeter shows an open circuit. Using a small screwdriver, the adjustment screw is turned counter clockwise until the meter shows continuity. The adjustment location is shown in Figure 13 and the calibration setup in Figure 14. After the switch closes the air pressure applied is lowered until the switch opens. We wanted to insure that the dead band is smaller than 15 PSI and that the switch opens when the pressure drops below 50 PSI.

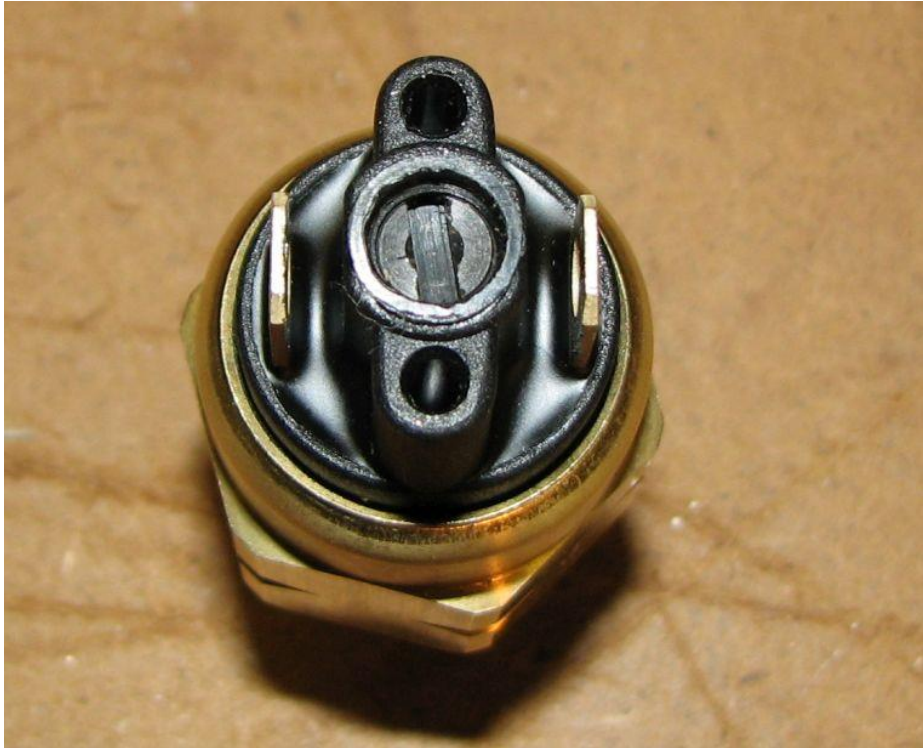
Figure 13 Adjustment shown between terminals

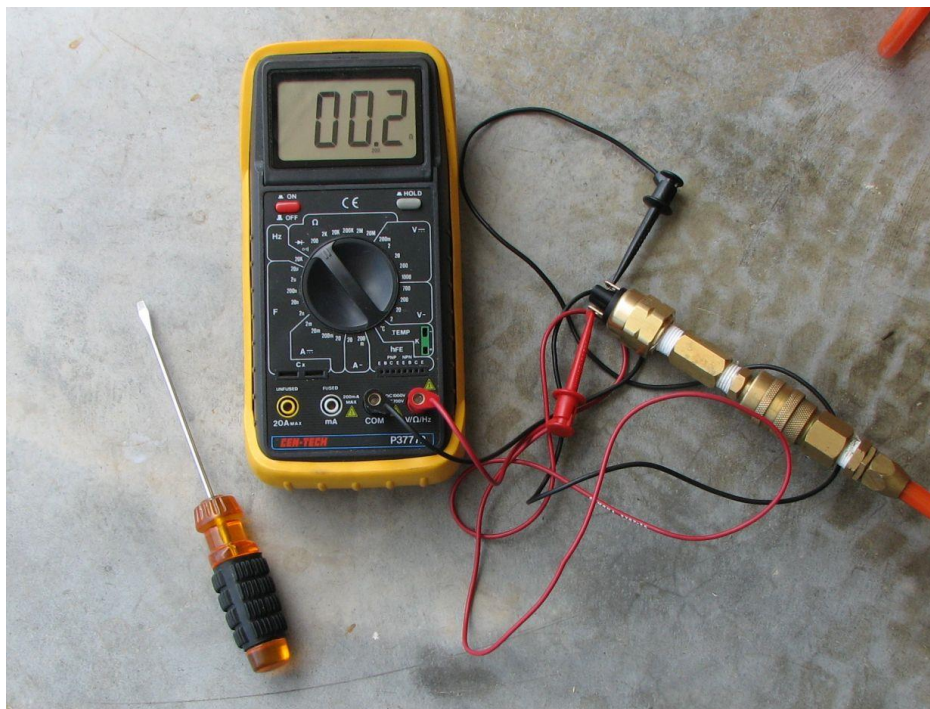
Figure 14 calibrating the pressure sensor to close at 65 PSI

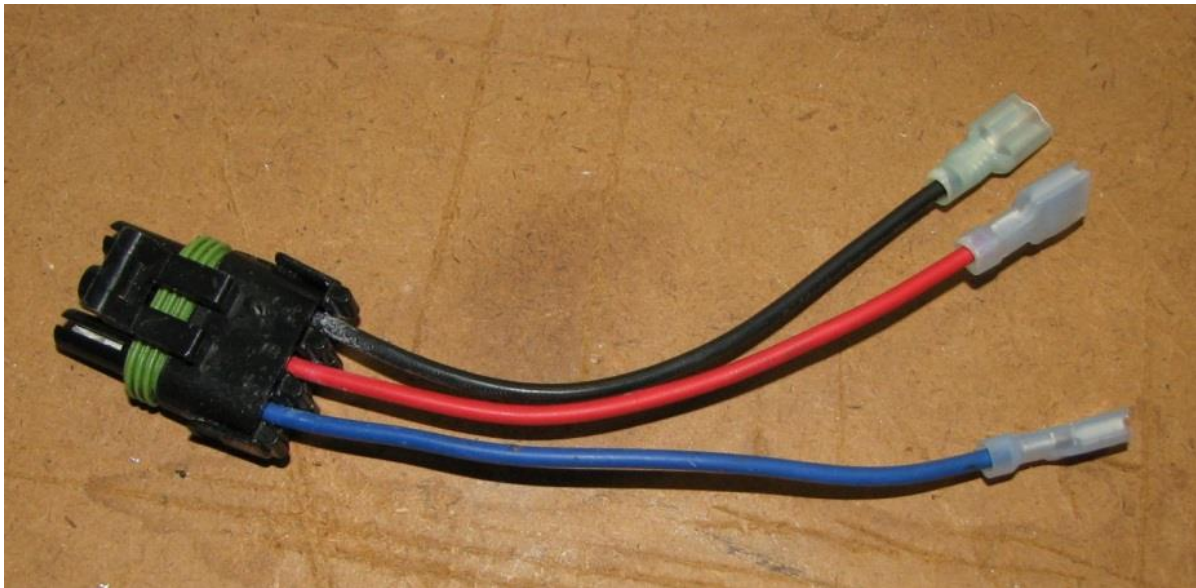
Figure 15 Connector from failed Nason pressure switch

The connector with leads was cut off of one of the failed Nason pressure switches and push-on terminals are crimped to the wires. Refer to Figure 15. Two push-on terminals were crimped to the half of the trailer extension with the male terminal on the red wire. Push-on terminals are crimped to a short length of wire and used to make the connection between the pressure switch and the relay coil. All other connections are completed with the two pole connector and the plug from the old Nason switch. The connections of components follow the circuit in Figure 8 and fashion the substitute parking brake switch shown in Figure 9.
